MONITORING REPORT

WSDOT Floating Bridge Stormwater Monitoring Project

Washington State Department of Transportation

June 30, 2005

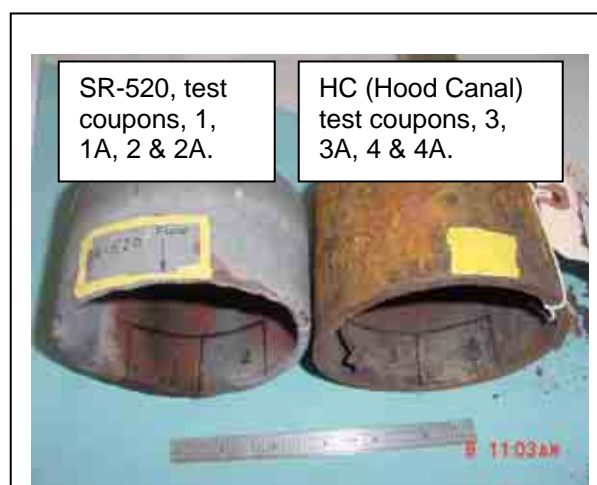
Figure 1, Shows the field samples received for metallurgical analysis.

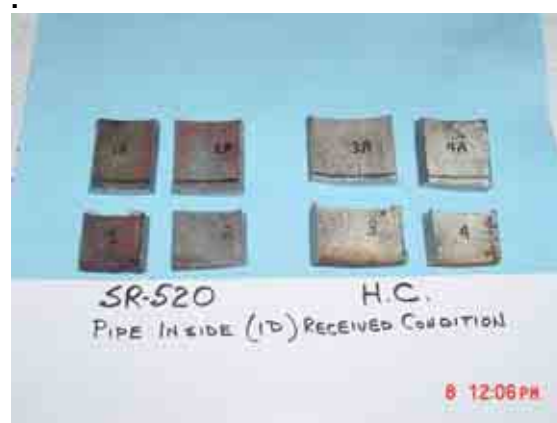
Figure 2, Shows the four (4) test coupons removed from each field sample. There are a total of 8 coupons.

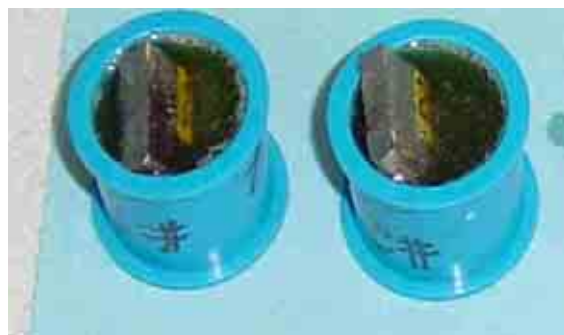
The SR-520 coupons are mounted so the plating and base metal is shown in cross section. Micrographs will concentrate on the galvanized plating.

Figure 3, Shows the SR-520 galvanized pipe coupon numbers 1 and 2.

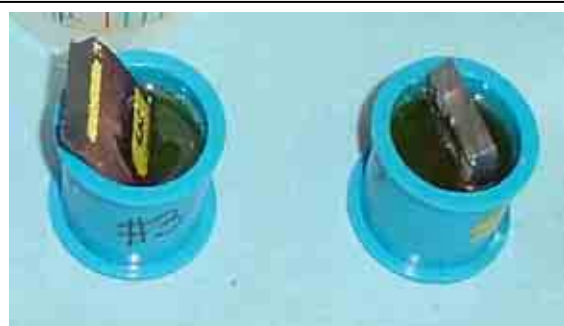
Note: The Hood Canal (HC) samples are in very poor condition. There appears from the initial visual inspection of these coupons that almost no galvanized coating remains.

Figure 4, Shows the Hood Canal (HC) galvanized pipe coupon numbers 3 and 4.

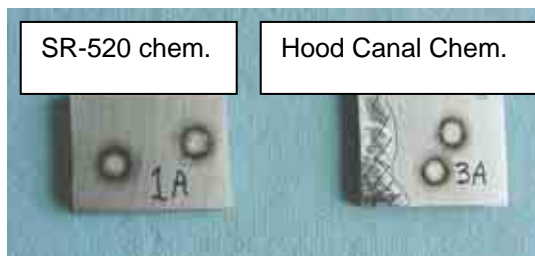
The blanks shown in Figure 5 were analyzed using an NIST trace instrument. The base metal zinc weight % is at the residual element level approaching 0.0 wt %.

Figure 5, Shows the SR-520 and HC spectrographic chemistry blanks.

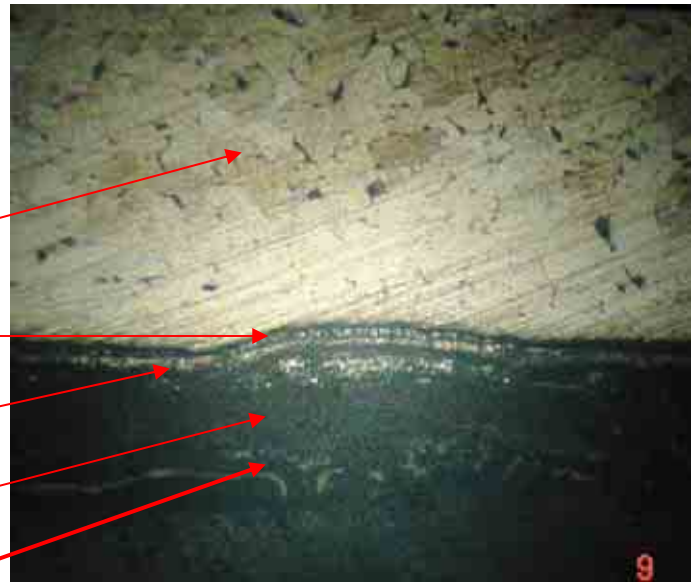
- Low carbon steel pipe
- Initial zinc tinning coat
- Second dip coat with columnar grains
- Sponge region with pits
- Thin metallic zinc layer

Figure 6, Specimen shown at 300X magnification.

1. I would recommend that **future drain ID galvanized coats** control the amount of dross or sponge that is deposited in the HOT DIP GALVANIZING PROCESS.
2. It may be necessary to call out a surface finish with dross or sponge regions limited to a maximum area of the pipe ID. It may also be necessary to limit the finish HOT DIP GALVANIZING thickness.

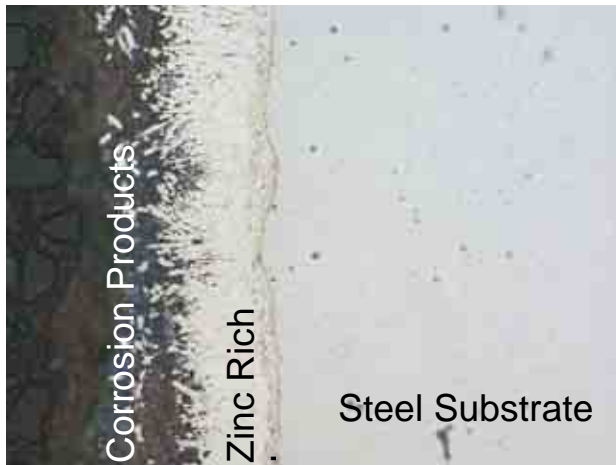
Figure 2

Energy dispersive x-ray spectra acquired from the ID surfaces. Large amounts of zinc, and lesser amounts of aluminum, silicon, phosphorus, sulfur, calcium, and iron were detected.

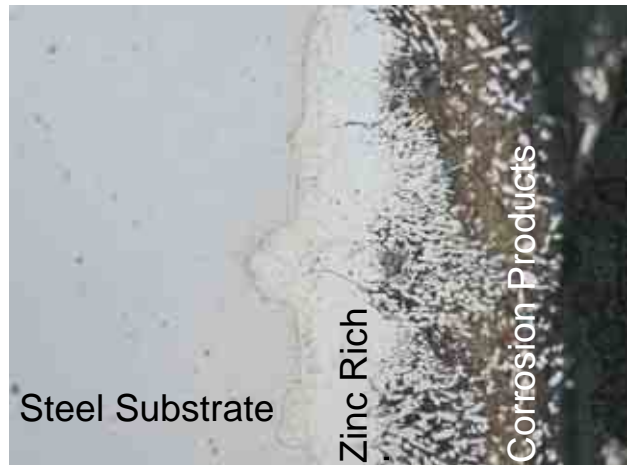
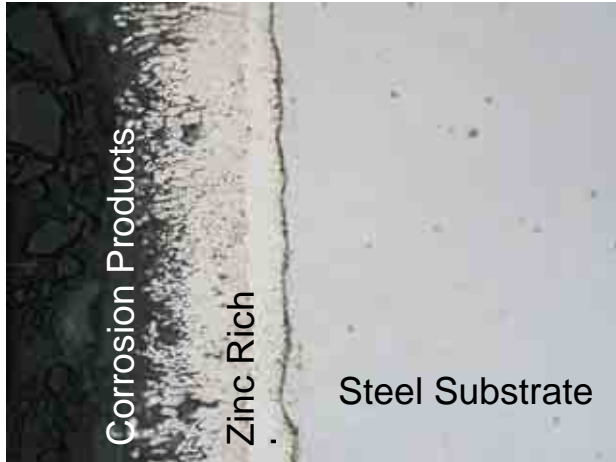
Figure 3

- 3) Examination of metallographic sections through the ID and OD surface of Sample 2A and the ID surface of Sample 4A revealed a dense, adherent metallic layer. The layer exhibited a columnar, dendritic microstructure. These features are consistent with a galvanized coating. No evidence of an apparent galvanized layer was revealed by the metallographic examination of the OD surface of Sample 4A. Metallographic sections through both coupons appear in Figures 3 and 4.

- 5) Corrosion products penetrated along the dendrite boundaries of the galvanizing. The appearance suggests substantial corrosion of the galvanized coating. Corrosion of the galvanized layer can be seen in Figures 3 through 6.
- 6) The pH of the OD and ID deposits on both coupons was approximately 6 to 7 pH units. Application of dilute hydrochloric acid to the surfaces yielded no odor of hydrogen sulfide. These observations suggest that corrosion was not the result of excessively acidic or alkaline conditions or due to the presence of or formation of sulfides. However, the coupons were likely contaminated during handling and sectioning prior to our receipt, and the above results may not be definitive.

Transverse metallographic sections through the ID surface (left) and the OD surface (right) of Sample 2A. Both surfaces contain an inner metallic coating layer and an outer layer of corrosion products. Corrosion appears to penetrate along a columnar dendritic structure within the inner coating layer. This structure is characteristic of galvanizing. As-polished, brightfield illumination.
